Company/home address - CCTV Survey Report : 21/02/17

Section: 1 **Start:** MH1 **End:** MHF **Road:** Your address
Length: 0.5 **Use:** Combined **Depth:** 0 **Place:** Your city/town

Section 1

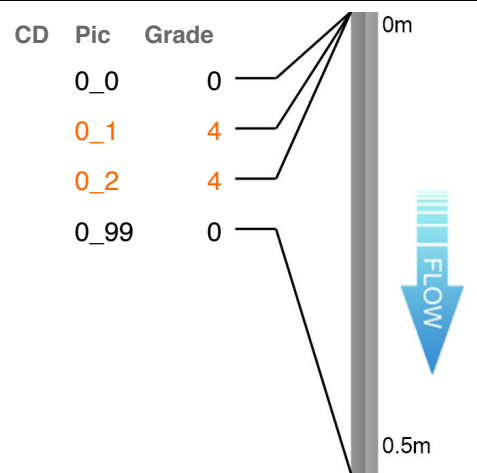
Position	Code	Description	CD	Pic	Grade
00.00m	IC	Start node type, inspection chamber		0_0	0
00.00m	CX	Defective connection 0 : 0mm Diameter		0_1	4
00.00m	JX	Defective junction 0 : 114mm Diameter		0_2	4
00.50m	MHF	Finish node type, manhole		0_99	0

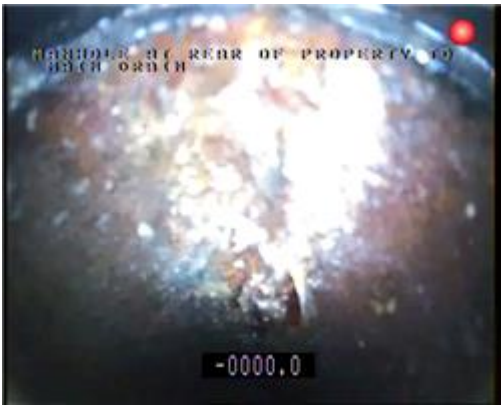
Pos	Code	Description	Image
00.00m	IC	Start node type, inspection chamber Inspection On Blocked Drain As Requested Found To Be Due To Poor Installation Of New Unit.	Image Provided - Ref: 0_0

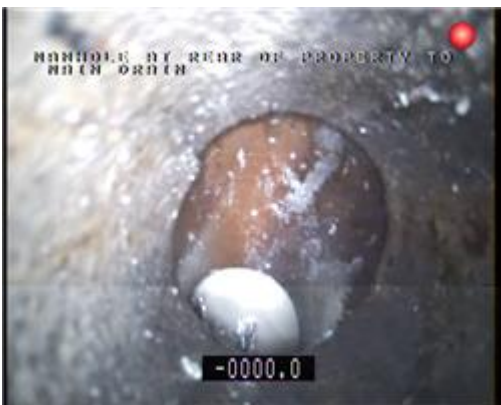
00.00m	CX	Defective connection at 0 o'clock: 0mm Diameter - Grade 4 Poor Installation Of Unit Showing Which Is Creating An Obstruction When Flush Is In Use This In Turn Will Promote A Build Up Of Waste Over Time And A Blockage	Image Provided - Ref: 0_1

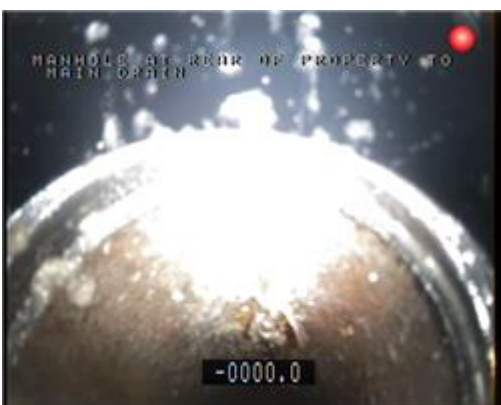
00.00m	JX	Defective junction at 0 o'clock: 114mm x 89mm Diameter - Grade 4 This Should Be Sufficient However Lip Has Been Generated Due To Poor Installation	Image Provided - Ref: 0_2

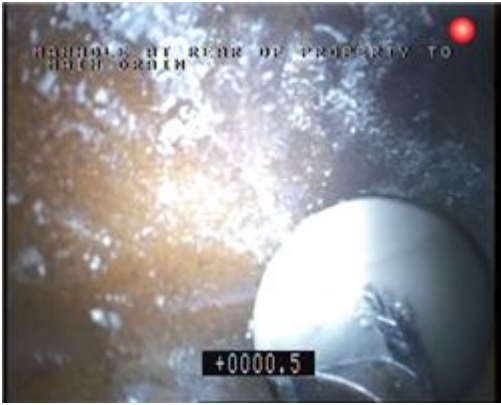
Pos	Code	Description	Image
00.50m	MHF	Finish node type, manhole MHF	<p>Image Provided - Ref: 0_9999</p>
